# **INVESTIGATIVE MONITORING ARMENIA 2022**

**Contract-No: 20940-C1/AM-HMC-2022/1**

EU4Environment in Eastern Partner Countries:  
Water Resources and Environmental Data (ENI/2021/425-550)

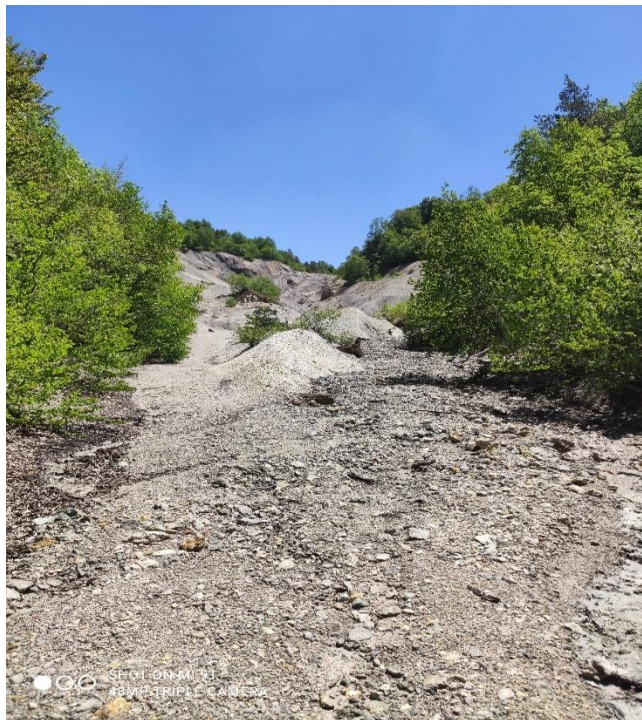
**Figure 5. Overburden in Tandzut site**

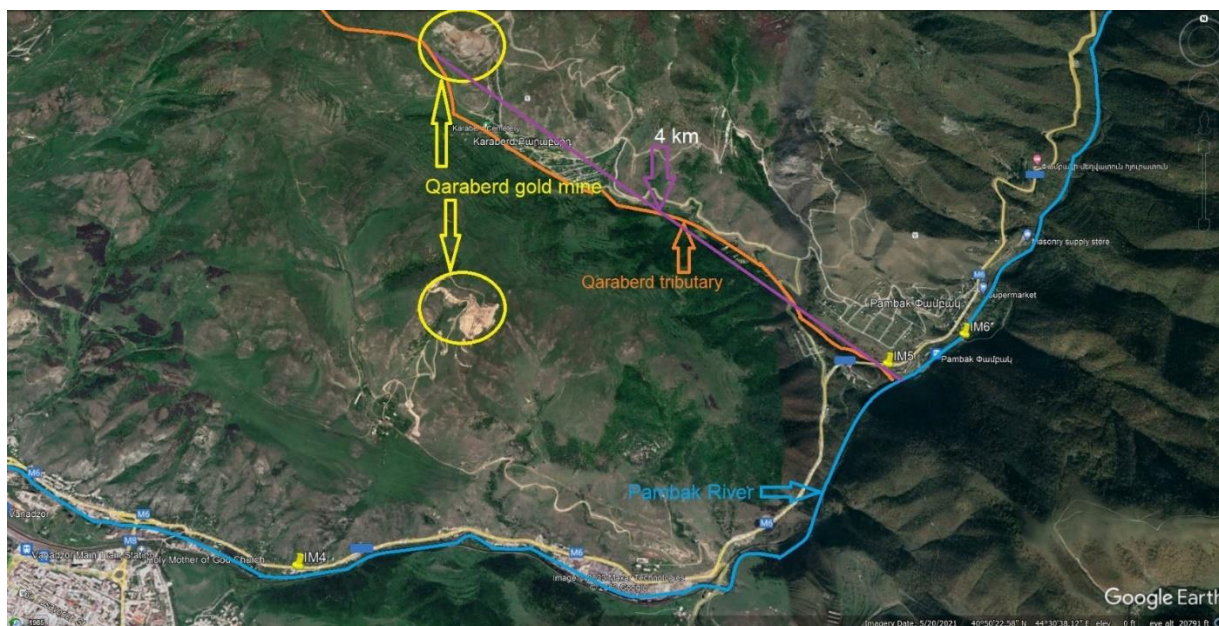
The Qaraberd gold mine is located in the Lori region, on the southern slope of the Bazum mountain range, on the left bank of the Pambak River, and 4.5 km from the city of Vanadzor to the northeast. The Qaraberd deposit was discovered back in the 60s of the previous centuries. Preliminary exploration of the mine began in 1993 and continued until the late 90s. In 2007-2008, the performed works covered an area of about 1,700 ha, which included not only the Qaraberd gold mine itself but also the Meghnut manganese and Zhdanov gold mines.

**Figure 7. Map of the Qaraberd site**

To study the impact of Qaraberd mining area on the Pambak River, the sites before and after mixing with the Qaraberd tributary, and in the tributary of Qaraberd need to be investigated. The flow length from the site of the Qaraberd mine to the confluence with the Pambak River the Qaraberd is approx. 4 km.

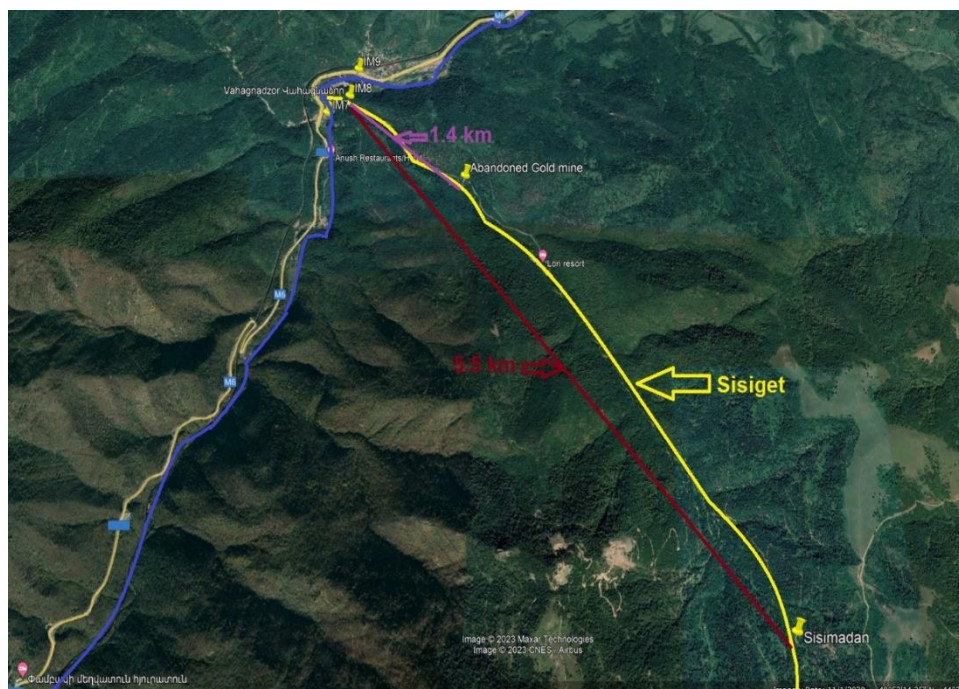
According to the summary reports of the geological works of Hanqadzor of 1956-1959 and the 1974 reports of exploration of the Hanqadzor mineral field and preliminary exploration works in the central area of the Hanqadzor copper mine at the beginning of the 19<sup>th</sup> century, small mining enterprises operated here. At present, the Hanqadzor mining area is not an object of right use. Mineral waste accumulated in the area is considered ownerless / abandoned and ground, rain and snow waters

penetrate the waste through cracks, mobilizing the compounds of heavy metals and flowing into the Pambak River (IM9) through the Sisiget river (IM8).

**Figure 8. Map of the Hanqadzor mining site**

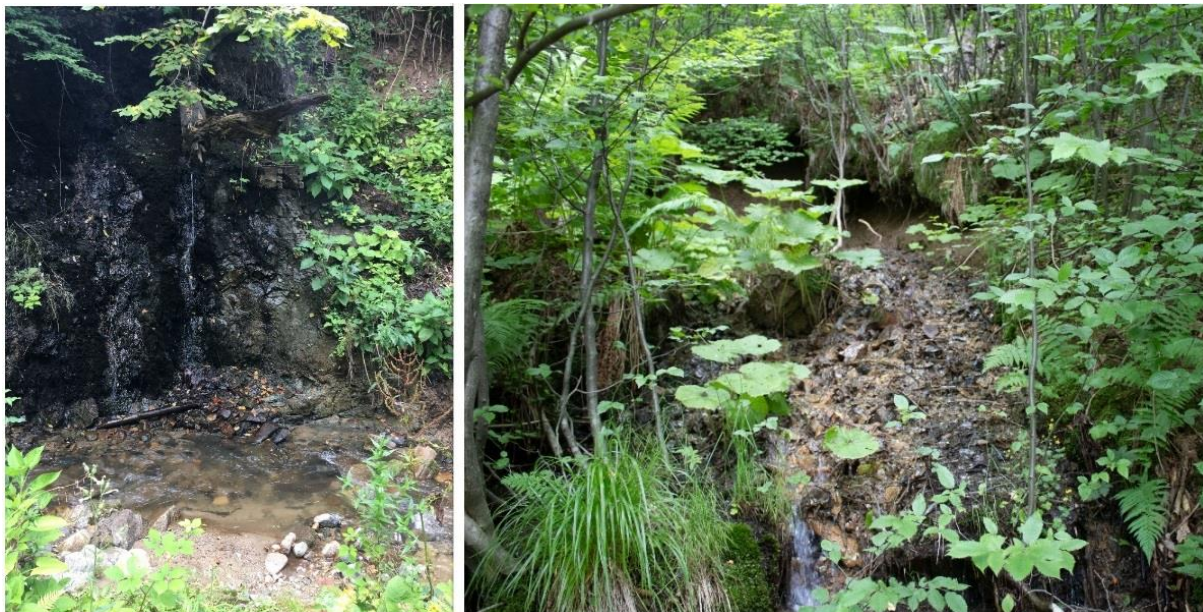
In July 2022, the HMC SNCO carried out investigative monitoring of soil pollution at the area of the Hanqadzor mining site. At that time, it was recorded that there were acid drainage flows on to the Sisiget stream, which flows into the Pambak River.

The main acid drainage into the Sisiget river was observed from the Sisimadan deposit - 5.5 km upstream the river mouth. Some acid drainage was also observed from the gold abandoned deposit - 1.4 km upstream the river mouth. It is possible that after flowing such a long distance the river cleans itself.

At these sites, arsenic, copper, lead, chromium, cadmium, zinc, and other heavy metals as well as sulphate, EC, and pH were measured.

**Figure 9. Acidic drainages from mine deposits floating into the Sisiget stream**

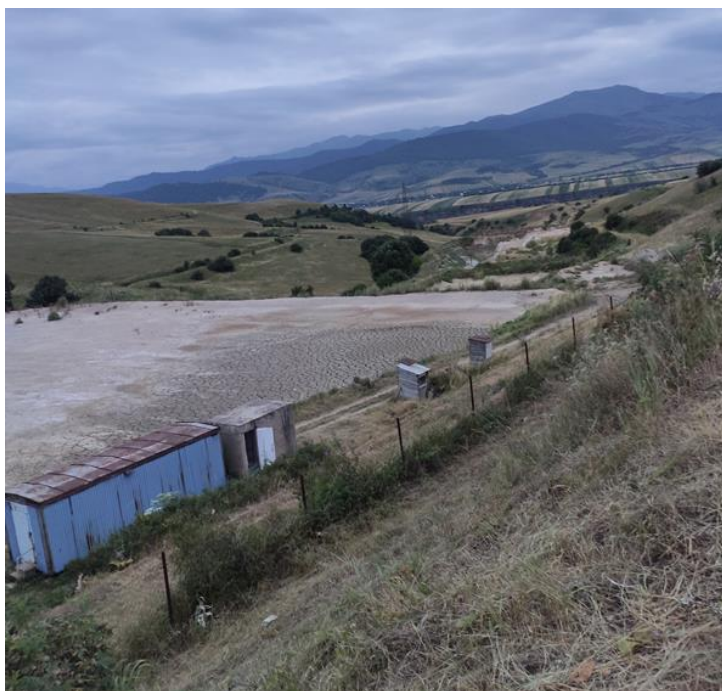
Mghart gold and silver mine is located 1.5 km west of Mghart village in the Dzoraget Basin. The mine has been in operation since 2005, but mining operations have been stopped today. It should be noted that the Mghart mine tailings are located right on the Mghart floodplain.

**Figure 10. Mghart mine tailings**

Mineral waste accumulated in the area is considered ownerless / abandoned and rain and snow waters penetrate the waste through cracks, mobilizing the compounds of heavy metals and flowing into the Dzoraget River through the Mghart floodgate.

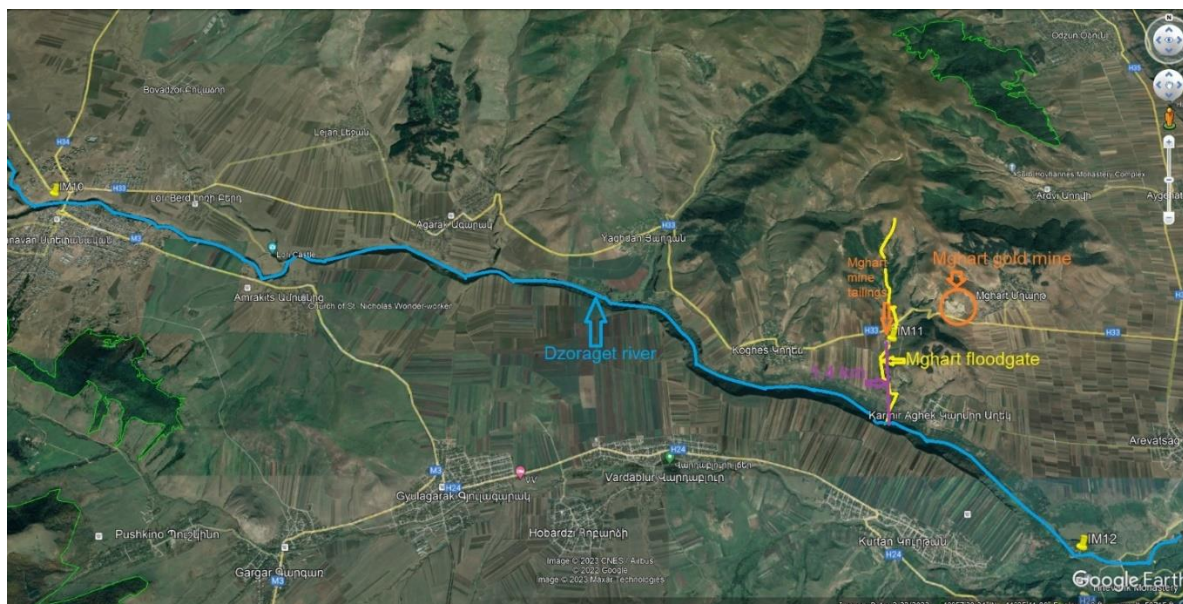
The flow length from the site of the Mghart mine tailings to the confluence with the Dzoraget River, the Mghart floodgate is approx 1.4 km.

**Figure 11. Map of the Mghart gold mining site**

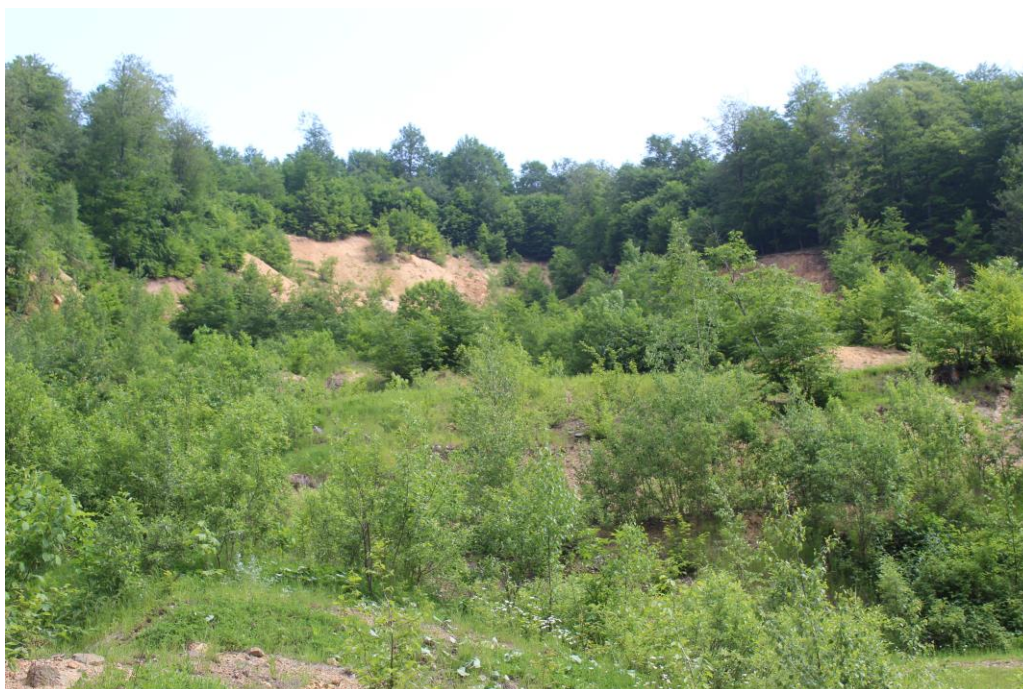
Currently, the Fioletovo gold mine is not an object of subsoil use rights. Land use waste accumulated in the area is treated as derelict/abandoned. According to the results of field studies, it was documented that the surfaces of the landfills underwent natural reclamation, and were covered with grass and shrubs.

**Figure 13. Landfall in Fioletovo mining site**

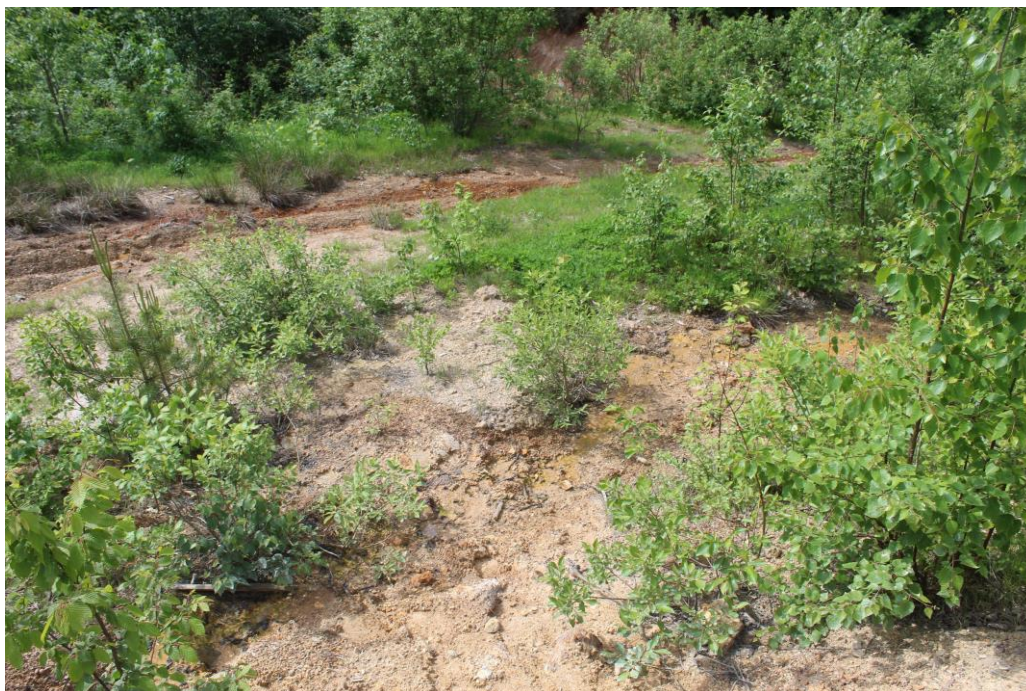
In June 2022, the employees of HMC SNCO carried out an investigative monitoring of soil pollution in the area of the Fioletovo site. At that time, it was observed that certain collapses occurred in the area and there were acid drainage flows to the Golovino River (see Figure 14), which flows into the Aghstev River after 2.6 km. A self-cleaning effect of the river is likely after flowing such a long distance.

**Figure 14. Acidic drainages floating into the Golovino river**

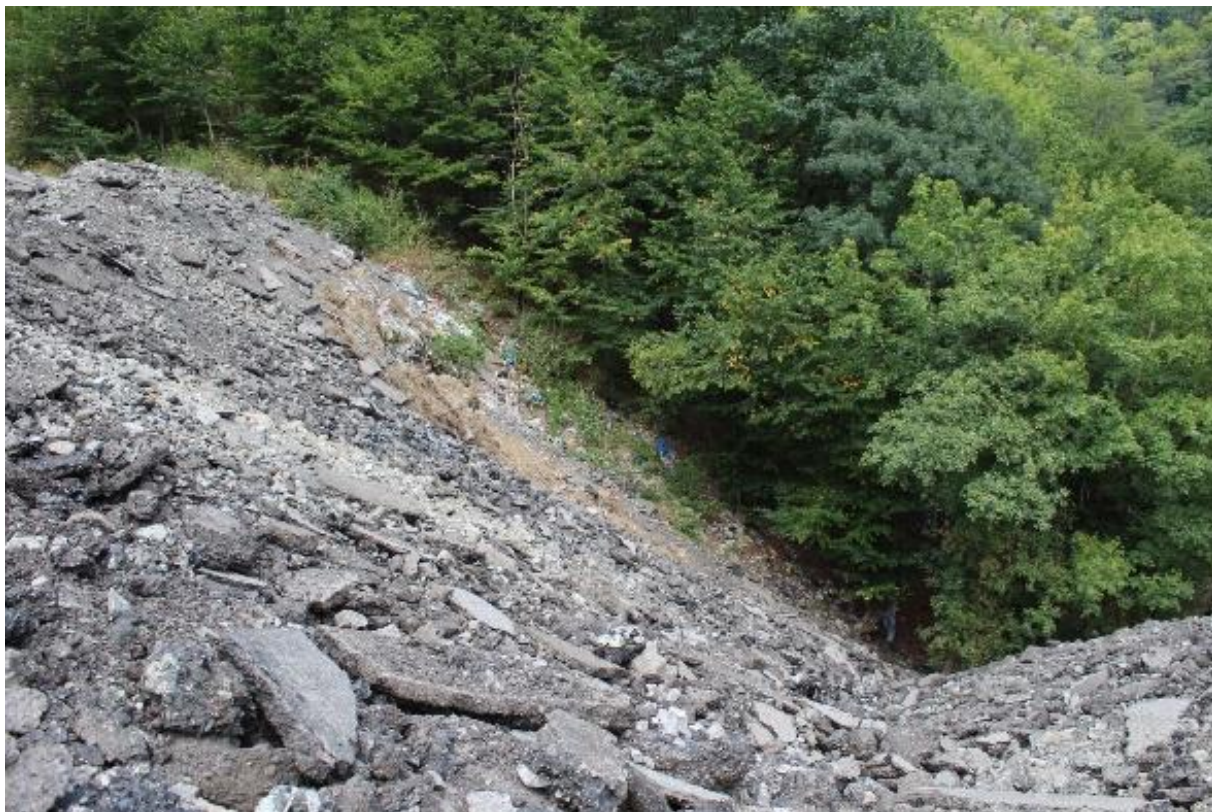
The old municipal dumpsite of Dilijan has been closed quite recently and has undergone some reclamation. It is located above the city of Dilijan, 100 m from the Aghstev river. Waste and its decomposition products accumulated piecemeal at the dumpsite through rain and snow waters and are flowing into the Aghstev River through the floodplain.

**Figure 15. Dilijan old municipal landfill**

An impact by the old municipal landfill of Dilijan is rather likely, but is expected to be during snow melts and mudslides. However, our fieldwork was carried out during the summer months and under clear weather conditions and it was not possible to record this effect in the field.

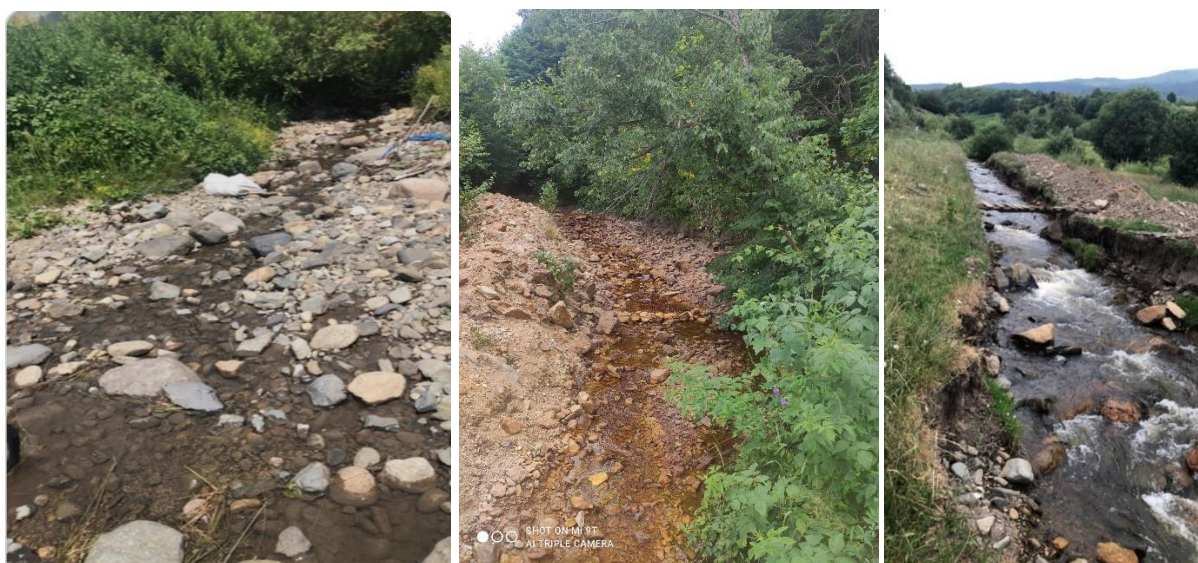
The Zhangot jur stream (IM2) is influenced by leachates of an open mine (see Figure 6). The influence of the Tandzut mining site on the Zhangot jur stream is obvious. The results of physicochemical analyses have shown that the water of Zhangot jur is acidic and has a rusty color (see Figure 16). Based on the chemical parameters, the water quality of the Zhangot jur stream at the site IM2 was assessed as bad, due to the high concentrations of ammonia, nitrate, sulphate, Cu, As, Mo, Mn, V, Co, Fe, Al, Sb, TIN, TSS.

The Zhangot jur stream is completely devoid of biodiversity. At the sampling site IM 2, in the mouth of the Zhangot jur stream no animals were found and the ecological quality has been assessed as bad.

At sampling site IM3 in comparison to sampling site IM1, the density of benthic macroinvertebrates decreased by 5 times, and the species diversity decreased from 19 to 12. However, the ecological status has decreased only from high to good (by nEQR-0.79 value).

*The investigative monitoring has revealed that Tandzut mining site has impact on to the Tandzut River through Zhangot jur stream.*

**Figure 16. Tandzut river upstream (IM1), Zhangot jur stream (IM2), Tandzut river after mixing of Zangotjur stream (IM3)**

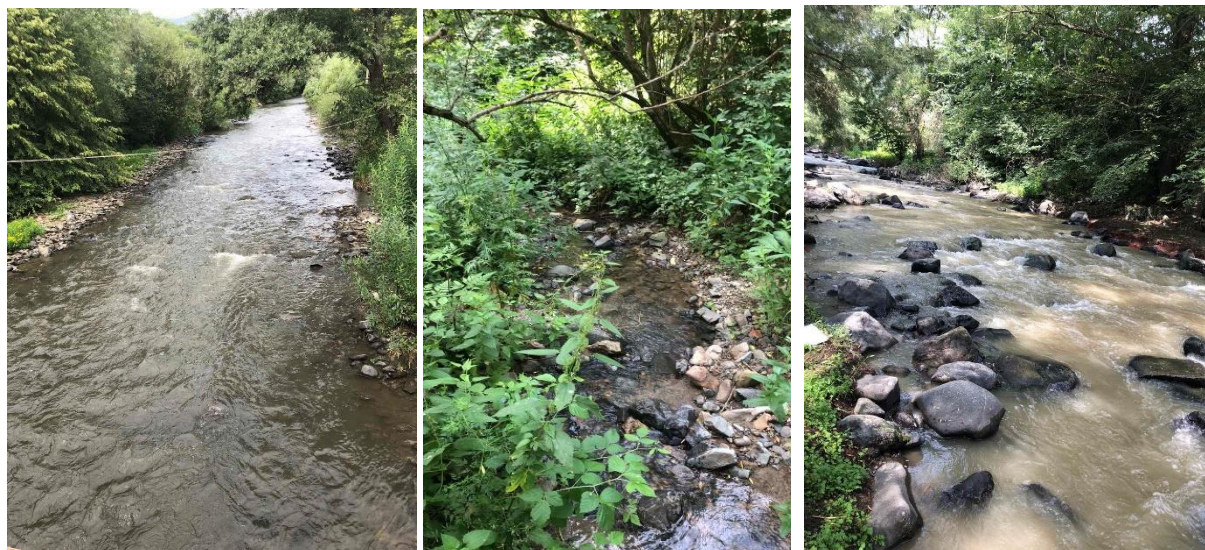
Based on the chemical parameters, the water quality of the Qaraberd River at the site IM5 was assessed as poor, due to the high concentrations of Mo. The ecological quality is assessed as good, by nEQR-0.69 value.

**Figure 17. Pambak river, up to an influence of Qaraberd river (IM4), Qaraberd river (IM5), and Pambak river after mixing of Qaraberd river (IM6)**

The results have shown that the Qaraberd mine does not have a significant impact on the biodiversity of the Qaraberd River (sampling site IM5). Almost all metals appear in concentrations comparable concentrations to most of the other sites. It is possible that after flowing such a long distance - 4 km, self-cleaning of the river takes place. This can be concluded, as IM6 shows significantly lower values for COD, BOD, NH<sub>4</sub> and P. However, nitrate is increased and could indicate oxidation processes, as also the O<sub>2</sub> saturation is higher at IM6 which shows an increased availability of dissolved oxygen. Unfortunately, there was no opportunity to visit the Qaraberd mine and see the situation on the spot.

The impact of Qaraberd mine on the Pambak River is not observed. The decline in the ecological status of the Pambak River is related to domestic pressures rather than the impact of the Qaraberd mine.

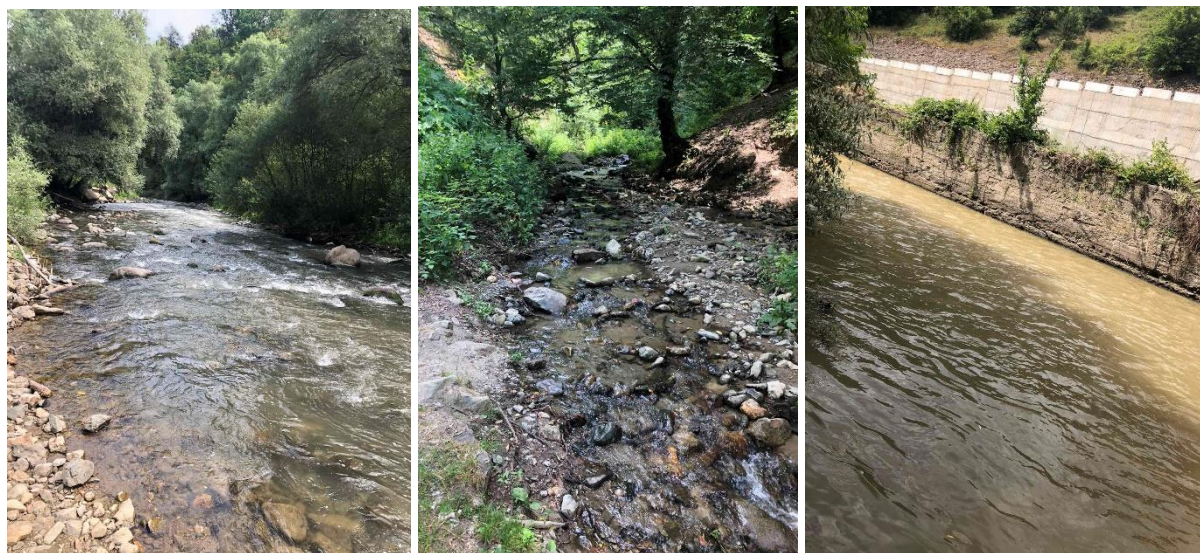
At the sampling site IM8 (Sisiget river mouth) the ecological quality was assessed as high, by nEQR-1.00 value. The water quality based on the chemical parameters was assessed as moderate due to the elevated concentration of molybdenum.

A large volume of acidic drainage discharges from the mine adit, which is comparable in volume to the volume of Sisiget in that location. However, the Hanqadzor abandoned mining area does not have a significant impact on the biodiversity of the river mouth of the Sisiget River.

**Figure 18. Pambak River up to the Vahagnadzor village (IM7), Sisiget river (IM8), Pambak River, after mixing of Sisiget River (IM9)**

At sampling site IM9, after the confluence of Sisiget river, the ecological quality is assessed as bad, by nEQR-0.05 value. The water quality based on the chemical parameters was assessed as bad due to the elevated concentration of nitrate ion (see Table 8). The Pambak river at the sampling site IM9 is again under utility-domestic pressure.

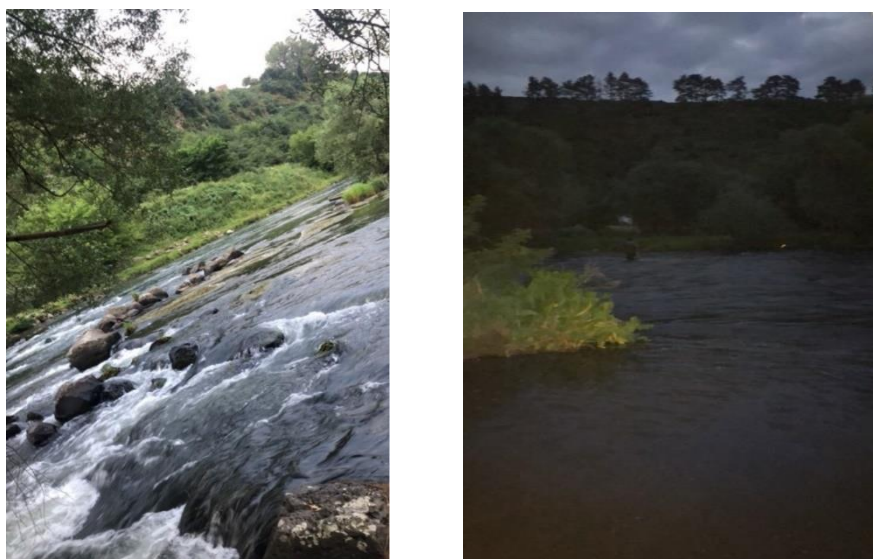
At sampling site IM10, Dzoraget river up to Stepanavan city, the ecological quality was assessed as good, by nEQR-0.67 value. The water quality based on the chemical parameters was assessed as moderate due to the elevated concentration of nitrate ion and vanadium.

**Figure 19. Dzoraget River up to the Stepanavan city (IM10), Dzoraget River after mixing Mghart stream (IM12)**

Since there was no water in the Mghart floodplain (sampling site IM11), it was not possible to assess the impact of the Mghart gold mine on the Dzoraget River.

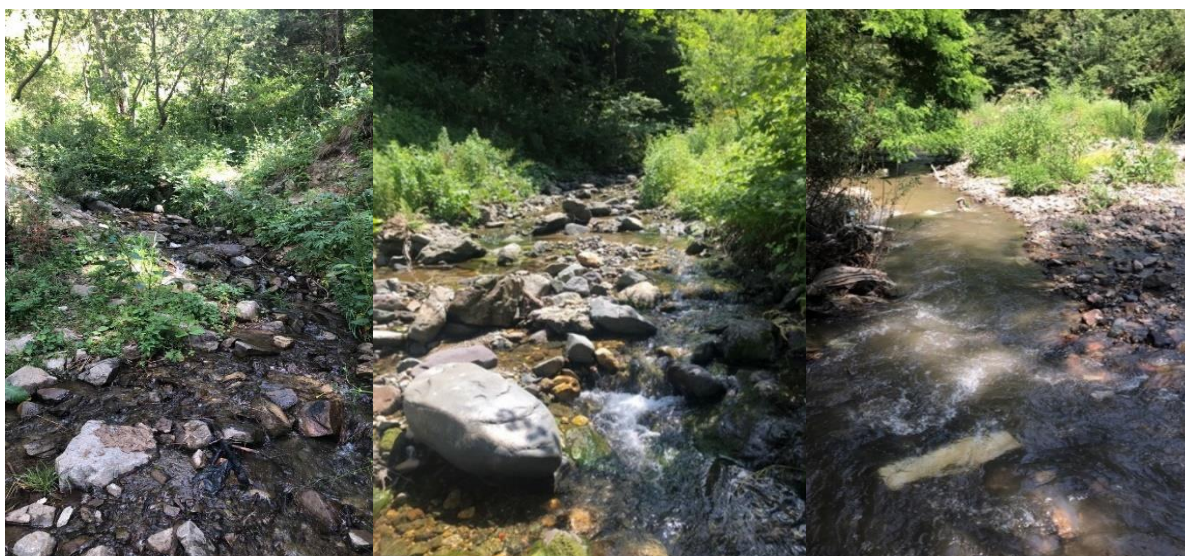
The Golovino River is to a certain extent influenced by Fioletovo abandoned mining site, which is caused by acidic drainage waters.

The Fioletovo mining site does not affect the ecological condition of the Aghstev River.

**Figure 20. Aghstev river upstream (IM13), Golovino river (IM14), Aghstev river up to Dilijan city (IM15)**

The quality at the sites around the Fioletovo mining site were assessed as good and moderate. A significant impact by the mining site could not be detected. However, acidic drainage water leaking from the mining site should be investigated. There is also an old municipal landfill, which potentially leaks during snow melt. This should be investigated further, preferably during snow melt, and remediation of the site should be considered. It is proposed to include the sampling site IM13 in the state water quality monitoring network.
